Message From Headquarters

Improper Hose Fabrication

Inspecting Unfamiliar Aircraft

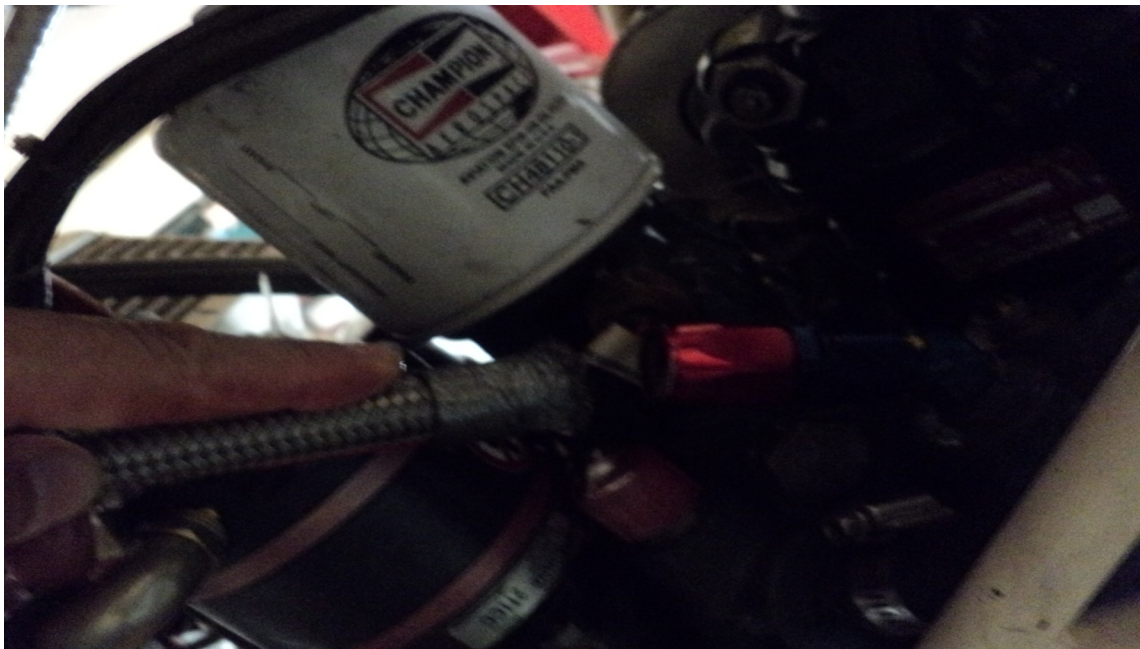
Inspection of the airplane revealed a hole in the left side of the engine case, near the base of the number two cylinder. There was no oil near this hole, and it was determined that this represented secondary damage. On further inspection it was found that the oil cooler hose that attached to a fitting at the top of the accessory case had come apart and there was a tremendous amount of oil all around this area. The hose assembly was a flexible line with stainless steel woven covering. The hose had backed out of the fitting, allowing the engine to pump all the oil overboard. It was determined that the person who fabricated that hose assembly had used an improper fitting for that type of hose and had not followed proper procedures when installing the fitting. The improper hose assembly was impossible to detect on a preflight or even a condition inspection.
